THE STUDY OF INDOOR MICROCLIMATE ON WOODEN CHURCHES TO BE INCLUDED AMONG ORADEA'S REPRESENTATIVE SIGHTS

Key words: air temperature, CO₂, indoor microclimate, Oradea, relative humidity, wooden church, tourism

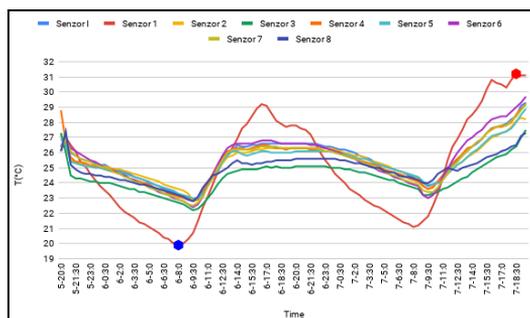
Figure 8. Temperature values recorded in the interval August 5-7, 2019 in the St. George church of Oradea

The interpretation of the obtained data shows that the indoor average air temperature was between 24.4°C (in the narthex) and 25.6°C (in the altar). The highest indoor air temperature was 31.2°C, recorded on August 7, 2019 at 6:30 in the church steeple. In contrast, the lowest indoor air temperature was 19.9°C, recorded on August 6, 2019 at 0:00 am (Figure 1). Based on the recorded data, average relative humidity varied between 62% in the narthex and 52% in the altar (Figure 6). The highest value for relative humidity was 66%, recorded on August 6, 2019 at 8 am, while the lowest was 44%, also recorded on August 6, 2019 at 5 pm. Given temperatures of 18-20°C, relative humidity must be 60%, and for temperatures of 24-25°C it should only be at 40% for the experience of thermal comfort. High relative humidity is conducive to the development of microbial flora and damages furniture, particularly the wooden pieces. According to Government

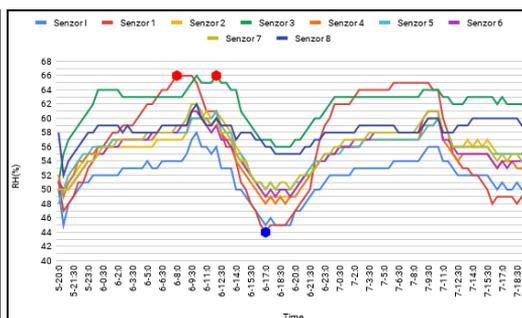
Figure 9. Relative humidity values recorded in the interval August 5-7, 2019 in the St. George church of Oradea

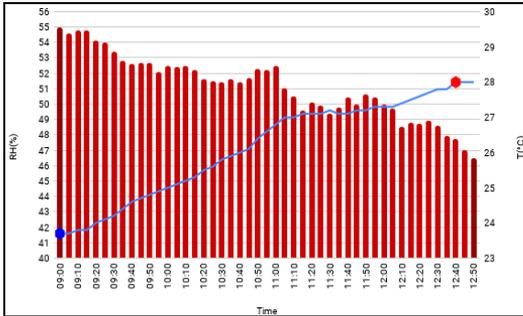
Figure 10. Temperature and relative humidity variations recorded on August 6, 2019 in the St. George church of Oradea

During the August 6 service, the data recorded between 9 am and 12:50 pm (Figure 10) show that temperatures vary from 23.7°C at 9 a.m. to 28°C at 12:40 p.m., which are values over the normal indoor air temperature limits, in accordance to the regulations in force in Romania recommending temperatures between 17°C and 24°C to achieve adequate indoor thermal comfort. Relative humidity values registered a downward trend as the air warmed up, with variations between 55% at 9 a.m. and 46% at 12:50 p.m. Given that optimal indoor comfort requires humidity values to fall between 45% and 55%, we see that optimal conditions are met here. On August 6, 2019 (Figure 11), CO₂ values varied from 381 ppm, the minimum value recorded at 9:05 a.m., to 652 ppm, the maximum value recorded at 10:50 a.m. The recorded values are optimal according to the health and hygiene norms in force (Hurezeanu, 2008).

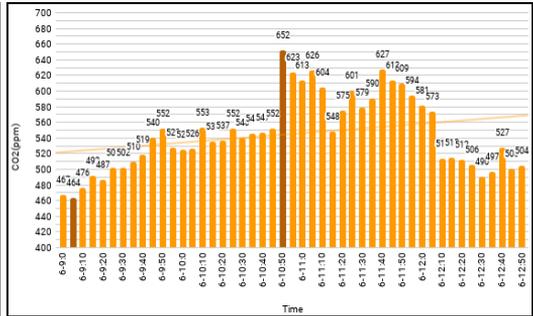
Figure 11. CO₂ variations recorded on August 6, 2019 in the St. George church of Oradea

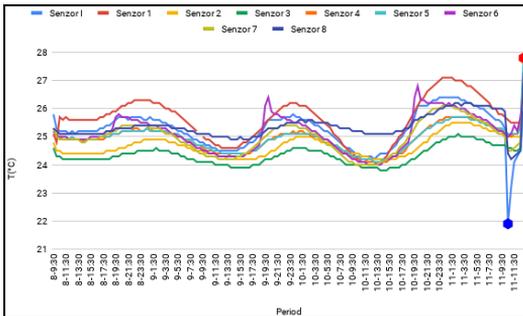
Figure 12. Temperature values recorded in the interval August 8-11, 2019 in the St. Michael and Gabriel church of Oradea

The interpretation of the yielded data shows, as seen on Figure 11, that the average indoor air temperature ranged between 24.4°C (recorded in the narthex) and 25.6°C (in the steeple). The highest indoor temperature was 27.8°C, recorded on August 11, 2019 at 1 pm inside the nave, where the majority of worshippers were found. In contrast, the lowest air temperature value was 21.9°C, also recorded on August 11, 2019 at 10:30 am (Figure 9), inside the altar due to the air conditioning system having been turned on.

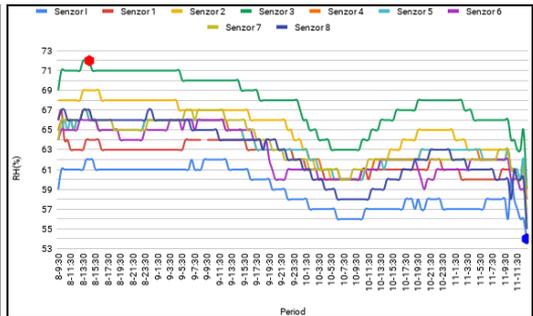
Figure 13. Relative humidity values recorded in the interval August 8-11, 2019 in the St. Michael and Gabriel church of Oradea

As seen on Figure 13, the analyzed data shows that average relative humidity fell between 68% in the narthex and 54% in the altar. The highest relative humidity value was 72%, noted on August 8, 2019 at 2:30 pm, while the lowest was 54%, spotted on August 11, 2019 at 1 pm. The church registered values slightly over the normal limits of temperature and relative humidity, in accordance to ISO 16814:2008, ISO 7730: 2006, SR EN 12792:2004, and the regulations in force in Romania, Law no. 263 of July 19, 2007 prescribing relative humidities between 55% and 65% and temperatures between 10°C and 24°C in order to ensure adequate indoor thermal comfort *** (2007).

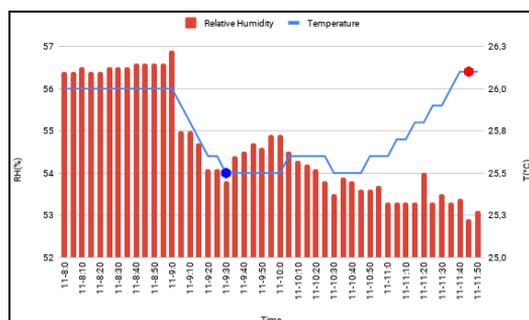
Figure 14. Temperature and relative humidity variations on August 11, 2019 in the St. Michael and Gabriel wooden church of Oradea

During the August 11 service, based on the data recorded between 8 a.m. and 11:50 a.m., it became apparent that, as seen on Figure 14, temperature values range between 25.5°C at 9:30 am and 26.1°C at 11:45 am. Such values are slightly over the normal limits for indoor air temperature, in accordance to regulations in force in Romania prescribing temperatures between 17°C and 24°C for adequate indoor thermal comfort. Relative

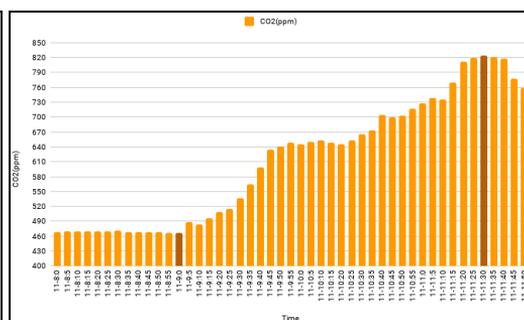
Figure 15. CO₂ variations recorded on August 11, 2019 in the St. Michael and Gabriel wooden church of Oradea

humidity values registered a downward trend, as seen on Figure 15: as the air warmed up, they decreased from 57% at 9 am to 53% at 11:45 am. Given that, for optimal indoor comfort levels the humidity must be between 45% and 55%, we may conclude that at this location the optimal conditions are met, with a maximum slightly in excess but still fitting the 50%-65% interval required for wooden buildings. On August 11, 2019 the CO₂ values varied from 467 ppm, the minimum recorded at 8:55:40 a.m. and at 9:00:40 a.m., to 824 ppm, the maximum recorded at 11:30 a.m. These recorded values are optimal, in accordance to the health and hygiene norms in force (Hurezeanu, 2008).

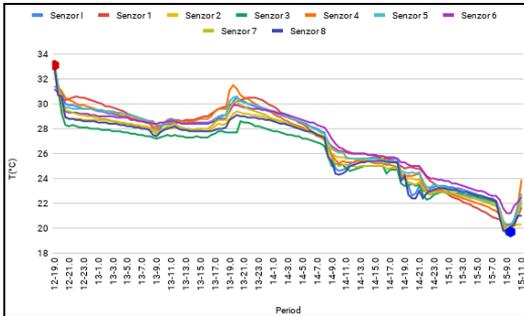
Figure 16. Temperature values recorded in the interval August 12-15, 2019 in the St. Spyridon church of Oradea

The interpretation of the recorded data reveals, as seen on Figure 16, that air temperatures averaged between 25.2°C (recorded in the narthex) and 26.4°C (in the nave, particularly near the lectern, where the cantors are). The highest indoor air temperature was 33.1°C, recorded on August 12, 2019 at 7 p.m. on the left-hand side of the nave, where the casket containing the holy relics is located, such that people come to worship them at the end of service. The same was true for the altar, where the thurible and the candles that had been burning during liturgy also had an influence. On the other hand, the lowest air temperature was 19.5°C, also recorded on August 15, 2019 between 9 a.m. and 9:30 a.m. (Figure 16), in the narthex, near the entrance door. As Figure 17 indicates, the analysis of the recorded data reveals that average relative humidity was between 64% in the narthex and 56% in the altar. The highest relative humidity was of 70%, recorded on August 14, 2019 at 4:30 p.m. and 6:30 p.m., whereas the lowest was of 47%, on August 12, 2019 at 7 p.m. in the altar, at floor level. The church thus registered values much over the normal limits for indoor air temperature, as per ASHRAE 62.1-2013, ASHRAE 55: 2004, and in

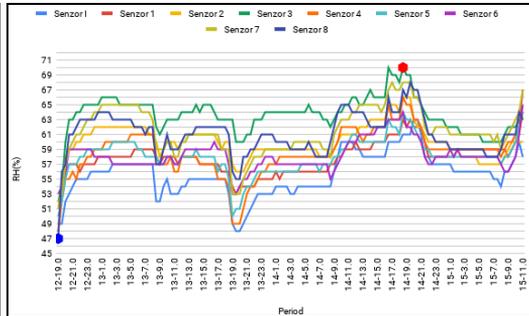
Figure 17. Relative humidity values recorded in the interval August 12-15, 2019 in the St. Spyridon church of Oradea

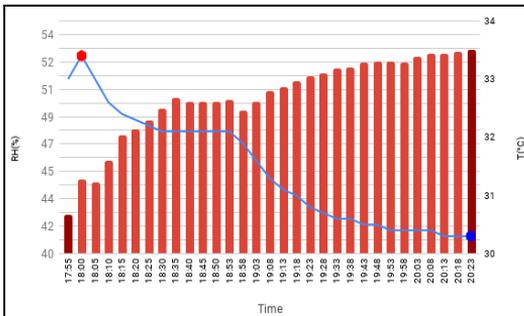
Figure 18. Temperature and relative humidity variations on August 12, 2019 in the St. Spyridon wooden church of Oradea

On August 12, 2019 (during vesper in the Assumption Fast), based on the measurements taken between 5:55 p.m. and 8:23 p.m. (Figure 18), it was visible that temperature values decreased from the maximum of 33.4°C at 6 pm to 30.3°C at 8:33 p.m. These values far exceed the normal limits for indoor air temperature, as per ASHRAE 62.1-2013, ASHRAE 55: 2004, EN-15251:2012, ISO 16814:2008, ISO 7730:2006, which recommend an interval from 17°C to 24°C for the attainment of adequate indoor thermal comfort. Relative humidity values (Figure 19) registered an upward trend as the air cooled, such that they varied from 43% at 5:55 p.m. to 53% at 8:23 p.m. Given that humidity must be between 45% and 55% for optimal indoor comfort levels, we may conclude that the optimal conditions are met here, with an insignificant decrease relative to the minimum point.

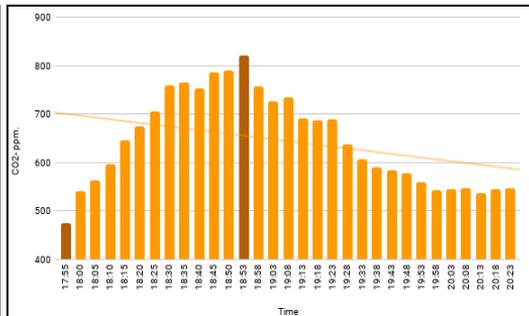
Figure 19. CO₂ variations on August 12, 2019 in the St. Spyridon wooden church of Oradea

On August 12, 2019 CO₂ values vary from 475 ppm, the minimum reached at 5:55 pm, to 820 ppm, the maximum reached at 6:53 p.m. Thus the recorded values are optimal, in accordance to the health and hygiene norms in force, EN-15251:2012, EN-15241:2011, EN-15242:2009, EN-13779:2008, and ASHRAE 62.1-2013.

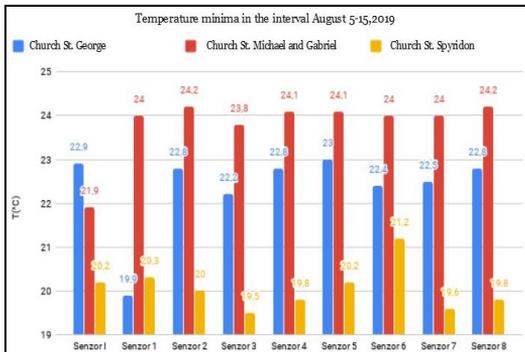
Figure 20. Temperature minima in the interval August 5-15, 2019 in the St. George, St. Michael and Gabriel, and St. Spyridon wooden churches of Oradea

The lowest minima for air temperature in the three churches (Figure 20) are very close together, ranging from 19.5°C in the narthex of the St. Spyridon church to 19.9°C in the steeple of the St. George church and to 21.9°C in the altar of the St. Michael and Gabriel church. The highest minima also vary in the same church order, namely 21.2°C at the lectern of the St. Spyridon church, 22.9°C in the altar of the St. George church, and 24.2°C in the narthex of the St. Michael and Gabriel church.

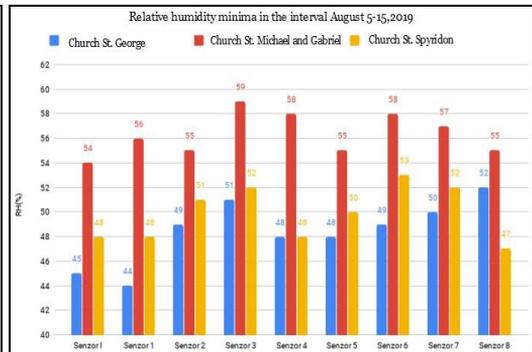
Figure 21. Relative humidity minima in the interval August 5-15, 2019 in the St. George, St. Michael and Gabriel, and St. Spyridon wooden churches of Oradea

Thus there are minor differences only in the case of the respective church areas. The lowest minima for relative humidity in the three churches (Figure 21) are very close together just as the case of temperatures has been. 44% in the steeple of the St. George church, 47% in the altar of the St. Spyridon church, and 54% in the altar of the St. Michael and Gabriel church all fall inside the interval recommended as optimal according to EN-15251:2012, EN-15241:2011, EN-15242:2009, EN-13779:2008, and ASHRAE 62.1-2013. The highest measured minima are 52% in the altar of the St. George church, 53% in the nave-lectern area of the St. Spyridon church, and 59% in the narthex of the St. Michael and Gabriel church. It is thus clear that these values fit in the interval considered as ensuring an optimal indoor comfort level for service participants, of 45%-55%, as well as in the interval of 50%-65%, optimal for wooden structures in accordance to EN-15251:2012, EN-15241:2011, EN-15242:2009, EN-13779:2008, ASHRAE 62.1-2013, and DM 10/2001.

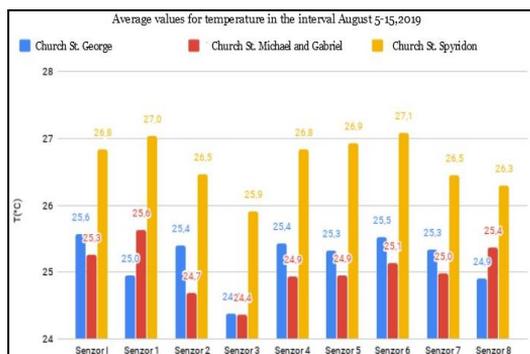
Figure 22. Average values for temperature in the interval August 5-15, 2019 in the St. George, St. Michael and Gabriel, and St. Spyridon churches of Oradea

The average values recorded in the three monitored churches fall slightly outside the optimal recommended interval of 17°C to 24°C for adequate indoor thermal comfort, in accordance to regulations in force in Romania. Average values for air temperature in the three churches (Figure 22) are very close together, ranging from 24.4°C in the narthex of the St. George church and St. Michael and Gabriel churches, to 25.6°C in the altar of the St. George church and the steeple of the St. Michael and Gabriel church, to 25.9°C in the narthex and respectively 27.1°C in the nave-lectern area of the St. Spyridon church. Thus there are minor differences only in the case of the respective church areas.

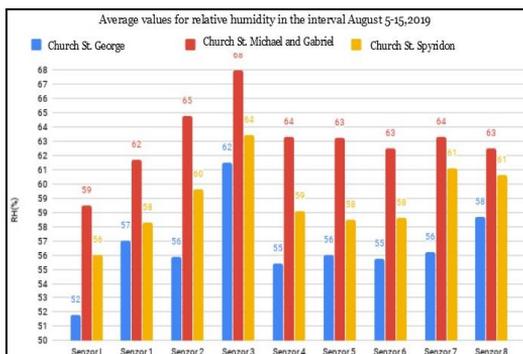
Figure 23. Average values for relative humidity in the interval August 5-15, 2019 in the St. George, St. Michael and Gabriel, and St. Spyridon churches of Oradea

Average values for relative humidity in the three churches (Figure 23) are very close together just as the case of temperatures has been. The lowest are in the altars: 52% in

the St. George church, 56% in the St. Spyridon church, and 59% in the St. Michael and Gabriel church. The highest average values measured are also in the altars: 62% in the St. George church, 64% in the St. Spyridon church, and 68% in the St. Michael and Gabriel church.

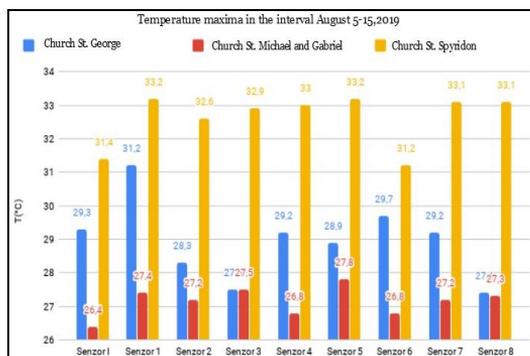
Figure 24. Temperature maxima in the interval August 5-15, 2019, in the St. George, St. Michael and Gabriel, and St. Spyridon wooden churches of Oradea

These obtained values ranged between 26.4°C and 33.2°C, thus greatly exceeding the recommended intervals. The maximum values for air temperature in the three churches (Figure 24) differ significantly, as they vary from 26.4°C in the altar (high up) and 27.5°C in the narthex (in the St. Michael and Gabriel church) to 27.4°C in the altar (floor level) and

31.2°C in the steeple (in the St. George church) and to 31.2°C in the nave by the lectern and 33.2°C also in the nave but on the left, by the relics (in the St. Spyridon church). Thus we may notice that there are minor differences among churches also regarding church areas. The maximum values for relative humidity in the three churches (Figure 25) range between 58% and 72%, much over the recommended interval of 45%-60%, considered optimal for the preservation of wooden structures and for indoor comfort, as per DM 10/2001, EN-15251:2012, EN-15241:2011, EN-15242:2009, EN-13779:2008, and ASHRAE 62.1-2013. These values enhance the heat sensation inside the church and prove conducive to the development of mold even at high temperatures.

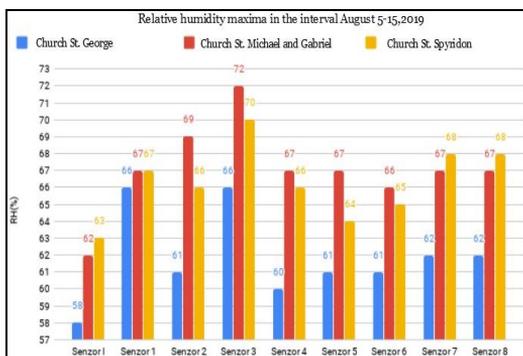
Figure 25. Relative humidity maxima in the interval August 5-15, 2019 in the St. George, St. Michael and Gabriel, and St. Spyridon wooden churches of Oradea

The lowest values are found in the altars: 58% in the St. George church, 62% in the St. Michael and Gabriel church, and 59% in the St. Spyridon church; while the highest values are in the narthexes: 66% in the St. George church, 70% in the St. Michael and Gabriel church, and 72% in the St. Spyridon church.
